**Flood Control Project Maintenance
Levee Inspections**

Fall 2016 Levee Maintenance Deficiency Summary Report

Sacramento River Basin

Lake County Watershed Protection District

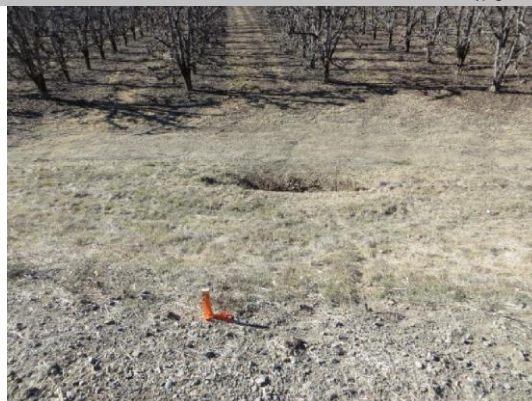
Photo 1 of 2 : UCIP_FA_2016_27630_51283.jpg

LM Start	2.84	Rating **	M	Issue No.	32
LM End	2.84	Issue Type +	En	Location *	LS
Category	Supplemental			GPS Latitude/Longitude	
				Start	End
Item	DWR UCIP Field Study			39.151257 °	39.151257 °
				-122.914908 °	-122.914908 °
DWR ID					
Comment Code					
Inspector Comment					
FS_ID:27630 DS_ID:21215 EP_NO: 11481 Repair Type: Non-Urgent Crossing Status: Found UCIP Comments: Soil partially blocking inlet and outlet. FIELD_STRUCT_DESC: 24-inch CM drainpipe through the levee, 12.0 feet below the crown. Flap gate on the waterward end. Concrete headwalls on both ends. (USACE-1961). This entry matches the Drainage or Irrigation Structure referenced in O&M manual (HLM 2.93). This pipe was retained under ABO No. 11481 (1975). FS Date: 1/22/2014

Concrete headwall and pipe visible at LS toe.

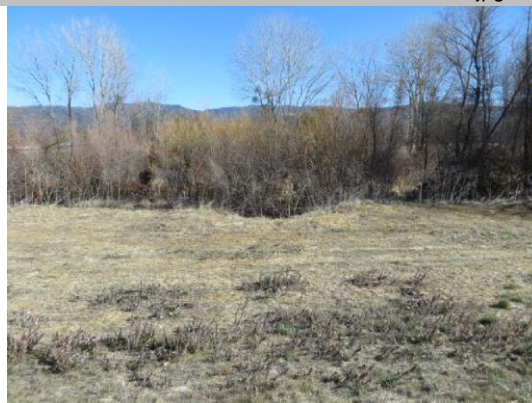
Photo 2 of 2 : UCIP_FA_2016_27630_51282.jpg

Concrete headwall and flapgate visible at WS berm.

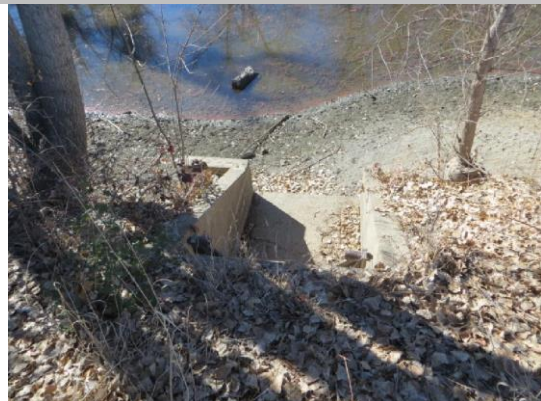
Photo 2 of 2 : UCIP_FA_2016_27863_51541.jpg

LM Start	0.54	Rating **	M	Issue No.	17
LM End	0.54	Issue Type +	En	Location *	LS
Category	Supplemental			GPS Latitude/Longitude	
				Start	End
Item	DWR UCIP Field Study			39.154786 °	39.154786 °
				-122.918703 °	-122.918703 °
DWR ID					
Comment Code					
Inspector Comment					
FS_ID:27863					
DS_ID:21217					
EP_NO: 11492					
Repair Type: Non-Urgent					
Crossing Status: Found					
UCIP Comments: Vegetation at inlet and wooden box failing at LS toe.					
FIELD_STRUCT_DESC: 42-inch CM drainpipe through the levee, 12.0					
feet below the crown. Flap gate on the waterward end. Concrete					
headwalls on both ends with a wooden retaining wall drop inlet at LS					
toe (USACE-1961). Originally included in O&M manual (HLM 0.55).					
This pipe was retained under ABO No. 11492 (1975). USACE O&M					
DWG No. CC-4-4-29.					
FS Date: 1/22/2014

Concrete headwall and flapgate visible at WS berm.

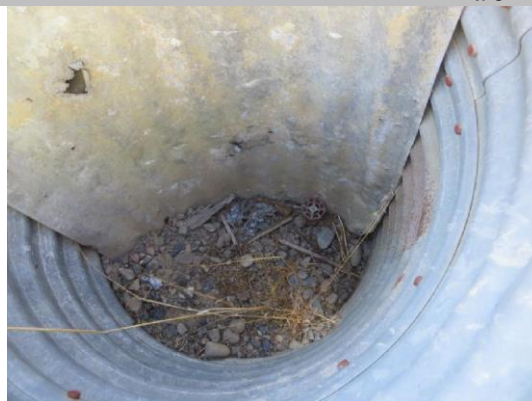
Photo 1 of 2 : UCIP_FA_2016_27891_51587.jpg

LM Start	0.75	Rating **	M	Issue No.	18
LM End	0.75	Issue Type +	En	Location *	LS
Category	Supplemental			GPS Latitude/Longitude	
				Start	End
Item	DWR UCIP Field Study			39.157443 °	39.157443 °
				-122.920110 °	-122.920110 °
DWR ID					
Comment Code					
Inspector Comment					
FS_ID:27891					
DS_ID:21219					
EP_NO: 11492					
Repair Type: Non-Urgent					
Crossing Status: Indicator Found					
UCIP Comments: Appears abandoned and if so should be done so properly.					
FIELD_STRUCT_DESC: 4-inch steel pipe through the levee, 2.5 feet below the crown. Siphon breaker in 24-inch CMP riser on LS shoulder. Pump on concrete platform on waterward side. Hose chute and concrete stairway on waterward slope. This pipe was retained under ABO No. 11492 (1975).					
FS Date: 1/22/2014

Valve visible at bottom of CMP riser on LS shoulder.

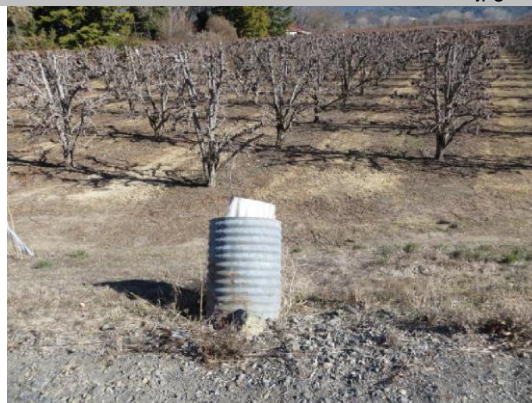
Photo 2 of 2 : UCIP_FA_2016_27891_51586.jpg

Siphon at LS shoulder inside 24-inch CMP riser.

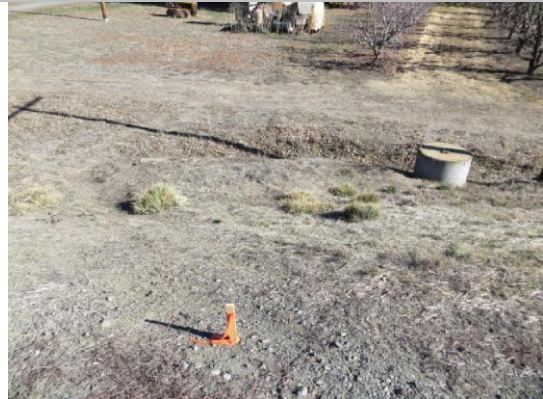
Photo 1 of 2 : UCIP_FA_2016_27892_51591.jpg

LM Start	0.77	Rating **	M	Issue No.	19
LM End	0.77	Issue Type +	En	Location *	LS
Category	Supplemental			GPS Latitude/Longitude	
				Start	End
Item	DWR UCIP Field Study			39.157759 °	39.157759 °
				-122.920301 °	-122.920301 °
DWR ID					
Comment Code					
Inspector Comment					
FS_ID:27892					
DS_ID:21220					
EP_NO: 11492					
Repair Type: Non-Urgent					
Crossing Status: Found					
UCIP Comments: Some sediment buildup at inlet.					
FIELD_STRUCT_DESC: 24-inch CM drainpipe through the levee, 10.0					
feet below the crown. Flap gate on the waterward end. Concrete					
headwalls on both ends. Concrete spillway on waterward slope to					
bottom of channel. (USACE-1961). This entry matches the Drainage or					
Irrigation Structure referenced in O&M manual (HLM 0.79). This pipe					
was retained under ABO No. 11492 (1975).					
FS Date: 1/22/2014

Concrete headwall visible next to concrete standpipe on LS toe.

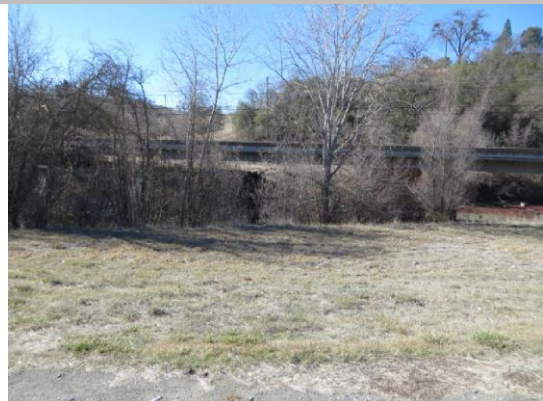
Photo 2 of 2 : UCIP_FA_2016_27892_51590.jpg

Concrete outfall visible off WS berm.

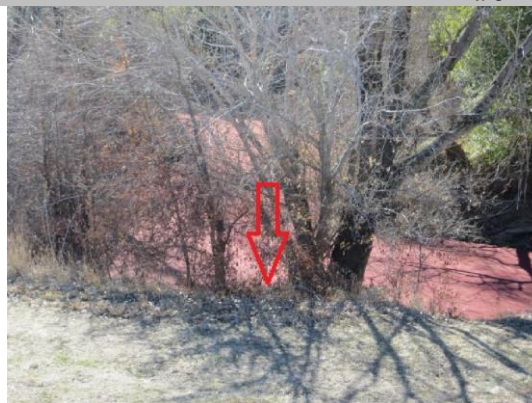
Photo 1 of 2 : UCIP_FA_2016_27894_51599.jpg

LM Start	0.93	Rating **	M	Issue No.	20
LM End	0.93	Issue Type +	En	Location *	WS
Category	Supplemental			GPS Latitude/Longitude	
				Start	End
Item	DWR UCIP Field Study			39.159736 °	39.159736 °
				-122.921042 °	-122.921042 °
DWR ID					
Comment Code					
Inspector Comment					
FS_ID:27894 DS_ID:21221 EP_NO: 11488 Repair Type: Non-Urgent Crossing Status: Found UCIP Comments: Concrete headwall on WS berm is being undermined. 2-foot of scour under headwall. FIELD_STRUCT_DESC: 42-inch CM drainpipe through the levee, 16.5 feet below the crown. Flap gate on the waterward end. Concrete headwalls on both ends. (USACE-1961). This entry matches the Drainage or Irrigation Structure referenced in O&M manual (HLM 0.94). This pipe was retained under ABO No. 11488 (1975). FS Date: 1/22/2014

Flapgate and headwall off WS toe.

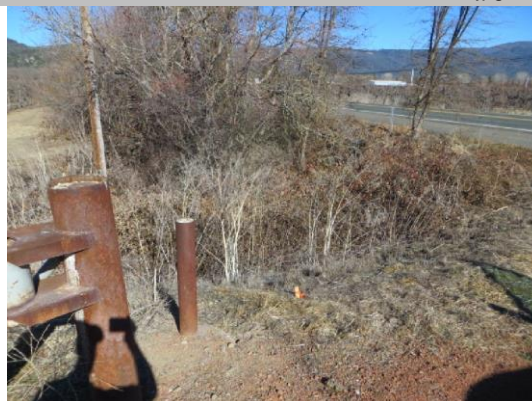
Photo 2 of 2 : UCIP_FA_2016_27894_51598.jpg

LM Start	0.93	Rating **	M	Issue No.	20 (cont)	
LM End	0.93	Issue Type +	En	Location *	WS	
Category	Supplemental			GPS Latitude/Longitude		
				Start		End
Item	DWR UCIP Field Study			39.159736 °		39.159736 °
				-122.921042 °		-122.921042 °
DWR ID						
Comment Code						
Inspector Comment						
FS_ID:27894 DS_ID:21221 EP_NO: 11488 Repair Type: Non-Urgent Crossing Status: Found UCIP Comments: Concrete headwall on WS berm is being undermined. 2-foot of scour under headwall. FIELD_STRUCT_DESC: 42-inch CM drainpipe through the levee, 16.5 feet below the crown. Flap gate on the waterward end. Concrete headwalls on both ends. (USACE-1961). This entry matches the Drainage or Irrigation Structure referenced in O&M manual (HLM 0.94). This pipe was retained under ABO No. 11488 (1975). FS Date: 1/22/2014

Concrete headwall on LS toe.

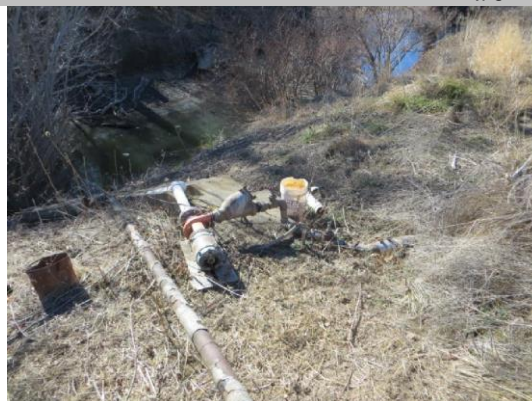
Photo 1 of 2 : UCIP_FA_2016_27903_51622.jpg

Comment Code						
Inspector Comment						
FS_ID:27903						
DS_ID:21248						
EP_NO: 11488						
Repair Type: Non-Urgent						
Crossing Status: Indicator Found						
UCIP Comments: Siphon breaker standpipe knocked over and covered with dirt. Pipe and appurtances appear to be in disrepair. Gate valves next to tank broken.						
FIELD_STRUCT_DESC: 6-inch steel irrigation pipe through the levee, 2.5 feet below the crown. Siphon breaker in 24-cmp riser on LS shoulder. Screw gate on waterside slope next to pump and 300-gallon tank. (USACE-1961). This entry matches the Drainage or Irrigation Structure referenced in O&M manual (HLM 1.02). This pipe was retained under ABO No. 11488 (1975).						
FS Date: 1/22/2014

Pump at concrete pad on WS berm.

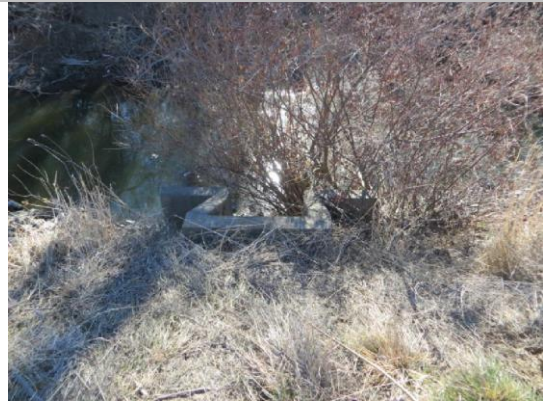
Photo 1 of 2 : UCIP_FA_2016_27943_51642.jpg

LM Start	0.99	Rating **	M	Issue No.	22
LM End	0.99	Issue Type +	En	Location *	LS
Category	Supplemental			GPS Latitude/Longitude	
				Start	End
Item	DWR UCIP Field Study			39.160117 °	39.160117 °
				-122.922144 °	-122.922144 °
DWR ID					
Comment Code					
Inspector Comment					
FS_ID:27943					
DS_ID:21222					
EP_NO: 11488					
Repair Type: Non-Urgent					
Crossing Status: Found					
UCIP Comments: Some vegetation buildup at inlet and outlet.					
FIELD_STRUCT_DESC: 24-inch CM drainpipe through the levee, 14.0 feet below the crown. Flap gate on the waterward end. Concrete headwalls on both ends. (USACE-1961). This entry matches the Drainage or Irrigation Structure referenced in O&M manual (HLM 1.01). This pipe was retained under ABO No. 11488 (1975).					
FS Date: 1/22/2014

Concrete Headwall on WS berm.

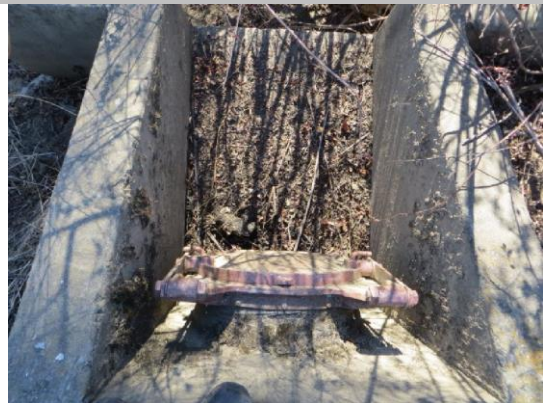
Photo 2 of 2 : UCIP_FA_2016_27943_51641.jpg

Headwall and flapgate on WS berm.

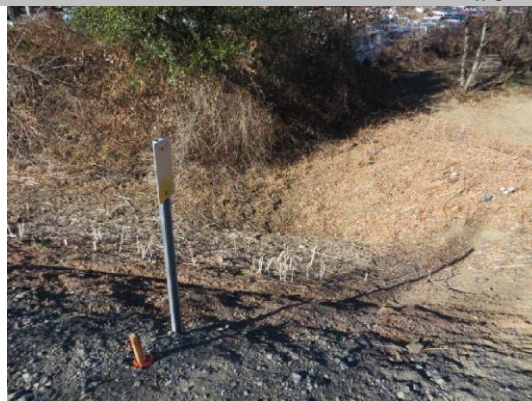
Photo 1 of 2 : UCIP_FA_2016_27944_51646.jpg

LM Start	1.07	Rating **	M	Issue No.	23
LM End	1.07	Issue Type +	En	Location *	LS
Category	Supplemental			GPS Latitude/Longitude	
				Start	End
Item	DWR UCIP Field Study			39.159803 °	39.159803 °
				-122.923501 °	-122.923501 °
DWR ID					
Comment Code					
Inspector Comment					
FS_ID:27944					
DS_ID:21223					
EP_NO: 11489					
Repair Type: Non-Urgent					
Crossing Status: Found					
UCIP Comments: Some sedimentation buildup at inlet and through pipe.					
FIELD_STRUCT_DESC: 24-inch CM drainpipe through the levee, 12.5 feet below the crown. Flap gate on the waterward end. Concrete headwalls on both ends. (USACE-1961). This entry matches the Drainage or Irrigation Structure referenced in O&M manual (HLM 1.09). This pipe was retained under ABO No. 11489 (1975).					
FS Date: 1/22/2014

Flasher on crown marks pipe location.

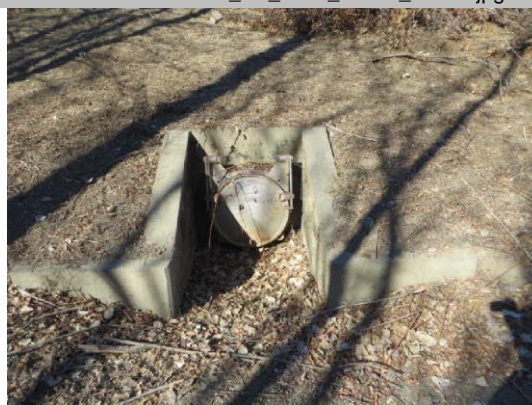
Photo 2 of 2 : UCIP_FA_2016_27944_51645.jpg

Flapgate and headwall visible on WS toe.

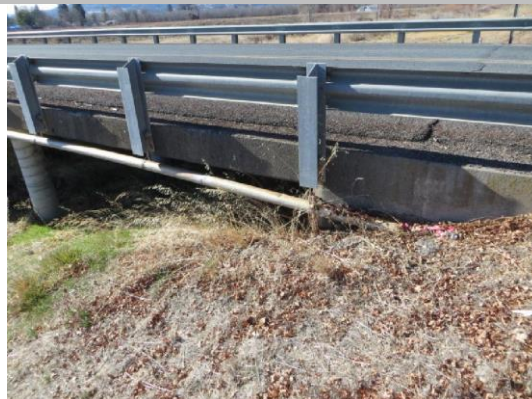
Photo 2 of 2 : UCIP_FA_2016_26907_49750.jpg

LM Start	0.53	Rating **	M	Issue No.	15 (cont)
LM End	0.53	Issue Type +	En	Location *	LS
Category	Supplemental			GPS Latitude/Longitude	
				Start	End
Item	DWR UCIP Field Study			39.176410 °	39.176410 °
				-122.902740 °	-122.902740 °
DWR ID					
Comment Code					
Inspector Comment					
FS_ID:26907 DS_ID:21226 EP_NO: 6303 Repair Type: Non-Urgent Crossing Status: Found UCIP Comments: Pipe open on waterwardside and should be plugged. FIELD_STRUCT_DESC: 4-inch steel irrigation pipe through the levee, 1.5-feet below the crown. Steel cutoff wall around the pipe at center of levee. Pipe connects to 4-inch exposed aluminum pipe connected to upstream side of bridge (Permit No. 6303, -A, 1969). FS Date: 1/9/2014

Pipe visible on upstream side of bridge.

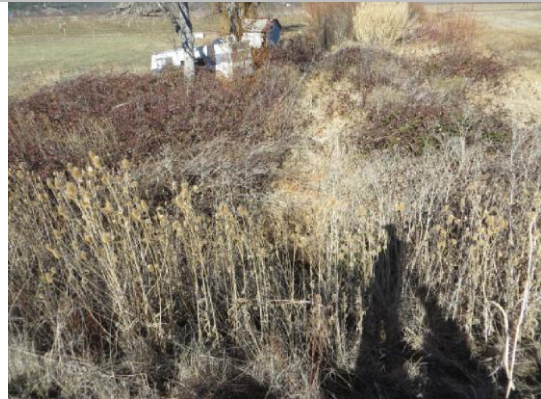
Photo 1 of 2 : UCIP_FA_2016_43043_49754.jpg

LM Start	0.75	Rating **	U	Issue No.	16
LM End	0.75	Issue Type +	En	Location *	LS
Category	Supplemental			GPS Latitude/Longitude	
				Start	End
Item	DWR UCIP Field Study			39.177676 °	39.177676 °
				-122.898917 °	-122.898917 °
DWR ID					
Comment Code					
Inspector Comment					
FS_ID:43043					
DS_ID:21227					
EP_NO: 11501					
Repair Type: Urgent					
Crossing Status: Found					
UCIP Comments: Pipe rusted through at connection to flapgate. Good indication pipe may need replacement. Video inspection recommended.					
FIELD_STRUCT_DESC: 24-inch CM drainpipe through the levee, 13.8 feet below the crown. Flap gate on the waterward end. Concrete headwalls on both ends. Originally included in the 1961 O&M manual					
This pipe was retained under ABO No. 11501 (1975).					
FS Date: 1/9/2014

Drainage canal at inlet on LS toe.

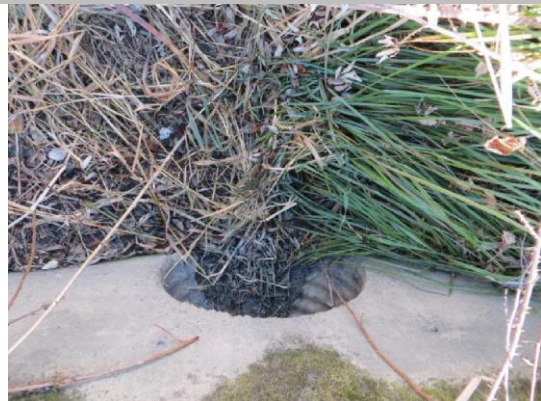
Photo 2 of 2 : UCIP_FA_2016_43043_49753.jpg

Pipe and concrete headwall visible in drainage channel on LS toe.

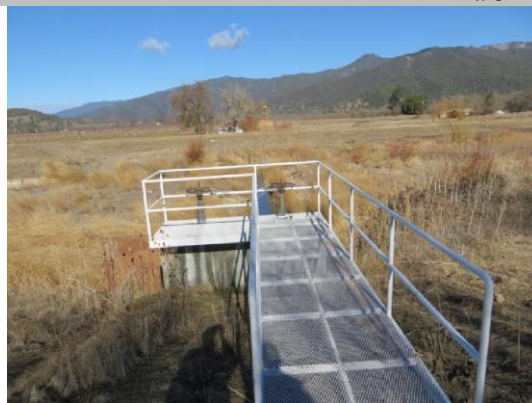
Photo 1 of 2 : UCIP_FA_2016_26897_49712.jpg

LM Start	0.31	Rating **	M	Issue No.	16	
LM End	0.31	Issue Type +	En	Location *	LS	
Category	Supplemental			GPS Latitude/Longitude		
				Start	End	
Item	DWR UCIP Field Study			39.177076 °	39.177076 °	
				-122.898879 °	-122.898879 °	
DWR ID						
Comment Code						
Inspector Comment						
FS_ID:26897						
DS_ID:21235						
EP_NO: 11507						
Repair Type: Non-Urgent						
Crossing Status: Found						
UCIP Comments: Some sediment buildup at LS toe.						
FIELD_STRUCT_DESC: 1 of 6: 36-inch CM irrigation pipe through the						
levee, 12.0 feet below the crown. Slide gate on waterward end. Steel						
walkway on waterward slope to slide gate. Concrete headwall on both						
ends. Originally included in 1961 O+M manual. Structure and pipes						
retained under ABO Permit No. 11507 (1975).						
FS Date: 1/9/2014

Slide gate at steel walkway on WS toe.

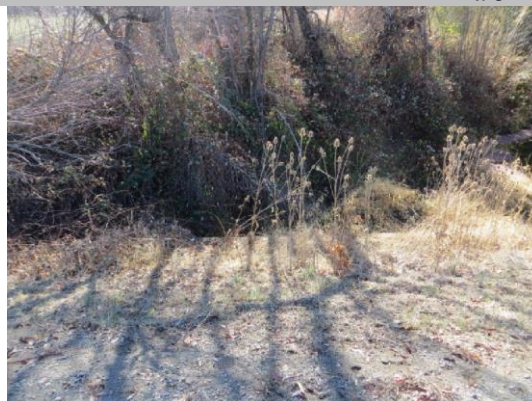
Photo 2 of 2 : UCIP_FA_2016_26897_49711.jpg

LM Start	0.31	Rating **	M	Issue No.	16 (cont)	
LM End	0.31	Issue Type +	En	Location *	LS	
Category	Supplemental			GPS Latitude/Longitude		
				Start	End	
Item	DWR UCIP Field Study			39.177076 °	39.177076 °	
				-122.898879 °	-122.898879 °	
DWR ID						
Comment Code						
Inspector Comment						
FS_ID:26897						
DS_ID:21235						
EP_NO: 11507						
Repair Type: Non-Urgent						
Crossing Status: Found						
UCIP Comments: Some sediment buildup at LS toe.						
FIELD_STRUCT_DESC: 1 of 6: 36-inch CM irrigation pipe through the						
levee, 12.0 feet below the crown. Slide gate on waterward end. Steel						
walkway on waterward slope to slide gate. Concrete headwall on both						
ends. Originally included in 1961 O+M manual. Structure and pipes						
retained under ABO Permit No. 11507 (1975).						
FS Date: 1/9/2014

Outlet visible at concrete headwall on LS toe.

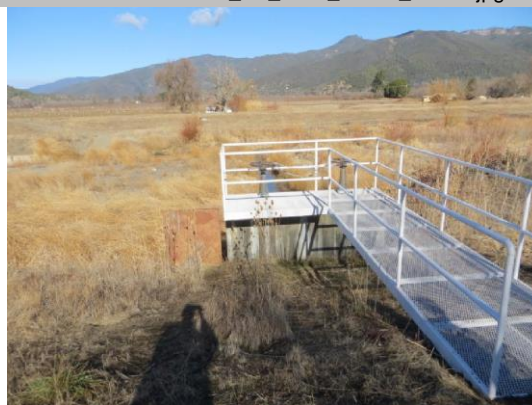
Photo 1 of 2 : UCIP_FA_2016_26891_49682.jpg

LM Start	0.31	Rating **	M	Issue No.	17
LM End	0.31	Issue Type +	En	Location *	LS
Category	Supplemental			GPS Latitude/Longitude	
				Start	End
Item	DWR UCIP Field Study			39.177074 °	39.177074 °
				-122.898902 °	-122.898902 °
DWR ID					
Comment Code					
Inspector Comment					
FS_ID:26891					
DS_ID:21234					
EP_NO: 11507					
Repair Type: Non-Urgent					
Crossing Status: Found					
UCIP Comments: Some sediment buildup on LS toe.					
FIELD_STRUCT_DESC: 2 of 6: 36-inch CM irrigation pipe through the levee, 12.0 feet below the crown. Slide gate on waterward end. Steel walkway on waterward slope to slide gate. Concrete headwalls on both ends. Originally included in 1961 O+M manual. Structure and pipes retained under ABO Permit No. 11507 (1975).					
FS Date: 1/9/2014

Slide gate on steel walkway at WS toe.

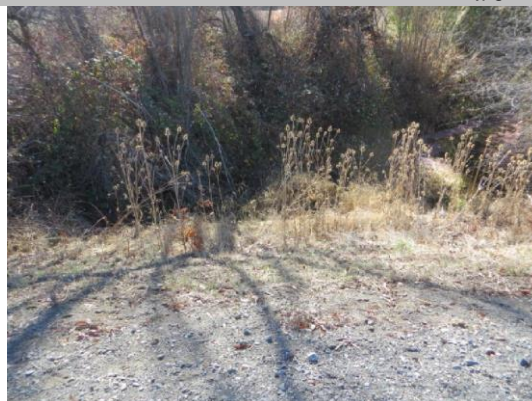
Photo 2 of 2 : UCIP_FA_2016_26891_49681.jpg

LM Start	0.31	Rating **	M	Issue No.	17 (cont)
LM End	0.31	Issue Type +	En	Location *	LS
Category	Supplemental			GPS Latitude/Longitude	
				Start	End
Item	DWR UCIP Field Study			39.177074 °	39.177074 °
				-122.898902 °	-122.898902 °
DWR ID					
Comment Code					
Inspector Comment					
FS_ID:26891					
DS_ID:21234					
EP_NO: 11507					
Repair Type: Non-Urgent					
Crossing Status: Found					
UCIP Comments: Some sediment buildup on LS toe.					
FIELD_STRUCT_DESC: 2 of 6: 36-inch CM irrigation pipe through the					
levee, 12.0 feet below the crown. Slide gate on waterward end. Steel					
walkway on waterward slope to slide gate. Concrete headwalls on both					
ends. Originally included in 1961 O+M manual. Structure and pipes					
retained under ABO Permit No. 11507 (1975).					
FS Date: 1/9/2014

Outlet visible at concrete headwall on LS toe.

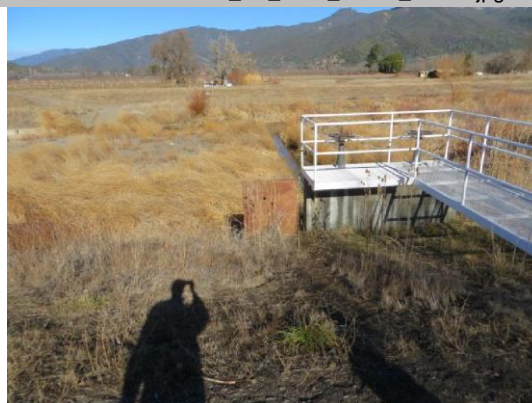
Photo 1 of 2 : UCIP_FA_2016_26888_49666.jpg

LM Start	0.32	Rating **	M	Issue No.	15
LM End	0.32	Issue Type +	En	Location *	LS
Category	Supplemental			GPS Latitude/Longitude	
				Start	End
Item	DWR UCIP Field Study			39.177078 °	39.177078 °
				-122.898926 °	-122.898926 °
DWR ID					
Comment Code					
Inspector Comment					
FS_ID:26888					
DS_ID:21233					
EP_NO: 11507					
Repair Type: Non-Urgent					
Crossing Status: Found					
UCIP Comments: Some sediment buildup at outlet on LS toe.					
FIELD_STRUCT_DESC: 3 of 6: 36-inch CM irrigation pipe through the levee, 12.0 feet below the crown. Concrete headwall on both ends.					
Steel slide gate plate blocks inlet on WS toe. Originally included in 1961 O+M manual. Structure and pipes retained under ABO Permit No. 11507 (1975).					
FS Date: 1/9/2014

Steel slide gate visible at concrete headwall on WS toe.

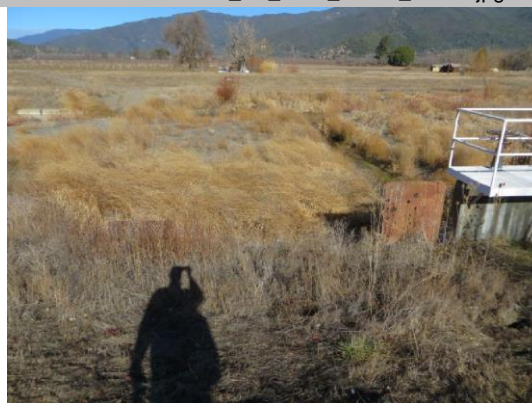
Photo 1 of 2 : UCIP_FA_2016_26883_49622.jpg

LM Start	0.32	Rating **	M	Issue No.	13
LM End	0.32	Issue Type +	En	Location *	LS
Category	Supplemental			GPS Latitude/Longitude	
				Start	End
Item	DWR UCIP Field Study			39.177070 °	39.177070 °
				-122.898967 °	-122.898967 °
DWR ID					
Comment Code					
Inspector Comment					
FS_ID:26883 DS_ID:21231 EP_NO: 11507 Repair Type: Non-Urgent Crossing Status: Found UCIP Comments: Some sediment buildup on LS toe. FIELD_STRUCT_DESC: 5 of 6: 36-inch CM irrigation pipe through the levee, 12.0 feet below the crown. Concrete headwall on both ends [Clover Creek Diversion Structure] . Steel slide gate blocks inlet on WS toe. Originally included in 1961 O+M manual. Structure and pipes retained under ABO Permit No. 11507 (1975). FS Date: 1/9/2014

Metal slide gate visible at concrete headwall on WS toe.

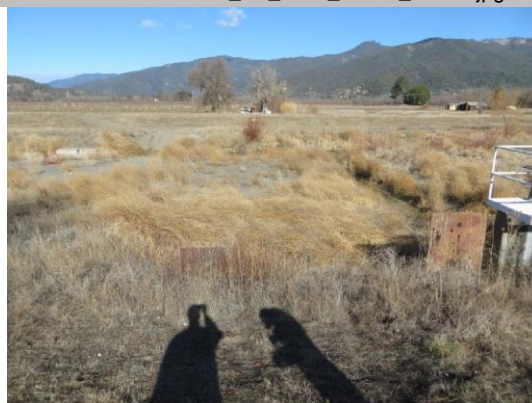
Photo 1 of 2 : UCIP_FA_2016_26877_49610.jpg

LM Start	0.32	Rating **	M	Issue No.	12
LM End	0.32	Issue Type +	En	Location *	LS
Category	Supplemental			GPS Latitude/Longitude	
				Start	End
Item	DWR UCIP Field Study			39.177066 °	39.177066 °
				-122.898986 °	-122.898986 °
DWR ID					
Comment Code					
Inspector Comment					
FS_ID:26877					
DS_ID:21229					
EP_NO: 11507					
Repair Type: Non-Urgent					
Crossing Status: Found					
UCIP Comments: Some sediment buildup at outlet on LS toe.					
FIELD_STRUCT_DESC: 6 of 6: 36-inch CM pipe through the levee, 12.0 feet below the crown [Clover Creek Diversion Structure]. Concrete headwall on both ends. Steel slide gate covers WS inlet. Structure and pipes retained under ABO Permit No. 11507 (1975). Originally included in 1961 O+M manual.					
FS Date: 1/9/2014

Steel slide gate visible at headwall on WS toe.

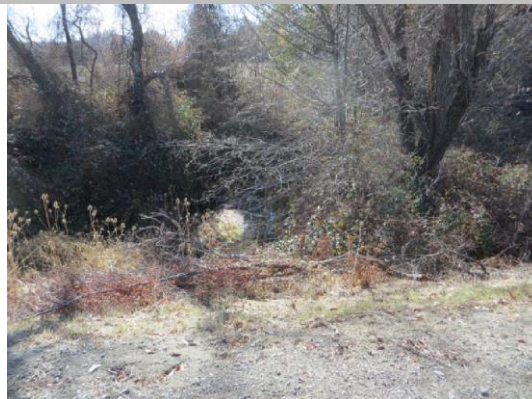
Photo 2 of 2 : UCIP_FA_2016_26877_49609.jpg

LM Start	0.32	Rating **	M	Issue No.	12 (cont)	
LM End	0.32	Issue Type +	En	Location *	LS	
Category	Supplemental			GPS Latitude/Longitude		
				Start	End	
Item	DWR UCIP Field Study			39.177066 °	39.177066 °	
				-122.898986 °	-122.898986 °	
DWR ID						
Comment Code						
Inspector Comment						
FS_ID:26877						
DS_ID:21229						
EP_NO: 11507						
Repair Type: Non-Urgent						
Crossing Status: Found						
UCIP Comments: Some sediment buildup at outlet on LS toe.						
FIELD_STRUCT_DESC: 6 of 6: 36-inch CM pipe through the levee,						
12.0 feet below the crown [Clover Creek Diversion Structure]. Concrete						
headwall on both ends. Steel slide gate covers WS inlet. Structure and						
pipes retained under ABO Permit No. 11507 (1975). Originally included						
in 1961 O+M manual.						
FS Date: 1/9/2014

Concrete headwall on LS toe.
